Manhole Inspection Summary

Manhole # S07UU_007MH

Insp Date: **7/19/07 10:31 AM**

Location Address: **3601 SPRINGDALE AVE** Cross Street: **GRANTLEY RD**

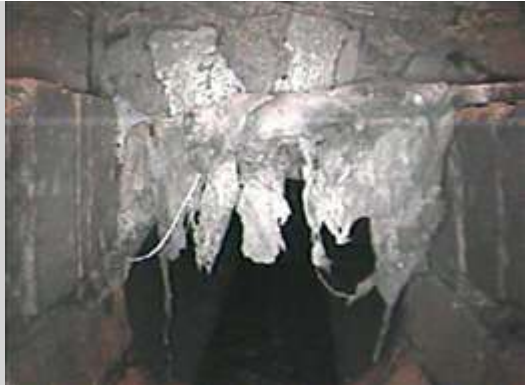
12 O'Clock Outflow

8 in. Circular Gravity Sewer
Pipe Out @ 12 O'Clock

BAR OBSTRUCTING VIEW

Pipe Height: (in.) Direct
Pipe Material: **Clay** ☐ Pipe Lined
Invert Depth: **10.84** (ft.) Flow Characteristics: **Slow**
Deposits: ☒ None ☐ Mud ☐ ~~Gravy~~ ☐ **Debris** ☐ Grease
Silt Depth: (in.) Deposits Extent:
Infiltration: **None** Pipe Seal Cond: **Sound**

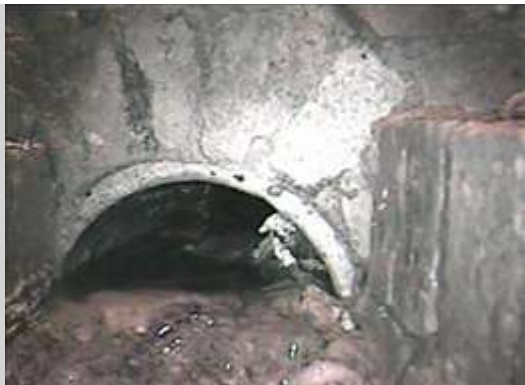
9 O'Clock Inflow

8 in. Circular Gravity Sewer
Pipe In @ 9 O'Clock

Pipe Height: (in.) Direct
Pipe Material: **Clay** ☐ Pipe Lined
Invert Depth: **10.72** (ft.) Flow Characteristics: **Slow**
Deposits: ☐ None ☐ Mud ☒ ~~Gravy~~ ☒ **Debris** ☐ Grease
Silt Depth: **4** (in.) Deposits Extent: **Heavy**
Infiltration: **None** Pipe Seal Cond: **Sound**
